# Access by Design

Summer 2006 Issue 107

# Kew Palace

*Kew Palace, George III's family home, set in the grounds of the Royal Botanic Gardens, reopened on the 27 April 2006, after a ten-year restoration project. In this building study we explore how Historic Royal Palaces improved access to this historic building as part of the project.*

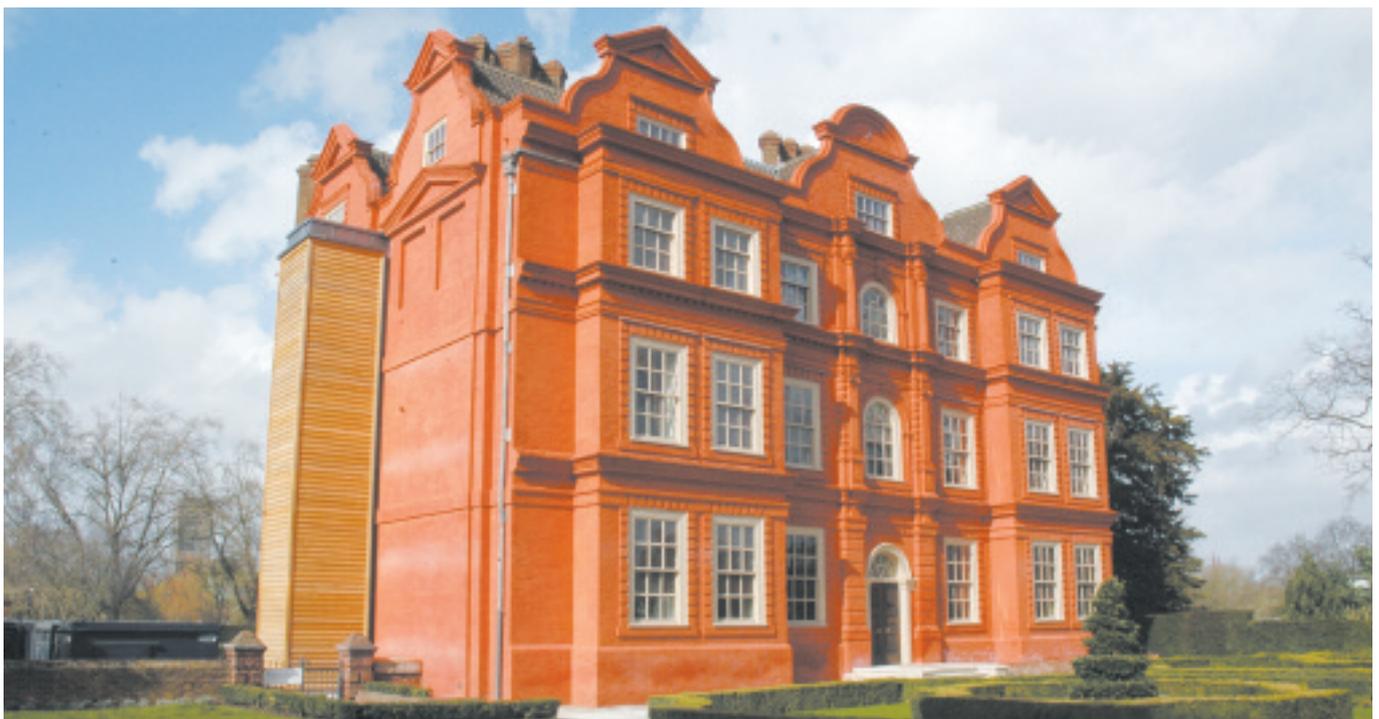
*Kew Palace exterior – showing the new lift shaft on the site of the former privy shaft*

The idea of introducing a passenger lift externally had been dictated by the absence of suitable locations within the compact interior layouts. Its preferred location, to the west and on the site of an 18th century water closet shaft, had evolved through preliminary consultation with EH.

The main lift's dimensions and construction were designed to minimise its visual and physical impact on the Palace's setting and historic building fabric. The steel frame shaft on a simple, concrete pad foundation has been erected and shaped independently of the original wall to form a tight abutment between its pedimented bays. Clad in lapped timber weather boarding and traditional leadwork over a brick plinth, the new facility responds to the original closet shaft's siting and visual simplicity. In contrast, the contemporary platform lift is of steel and glass and sits discreetly within the undercroft's new retaining brick wall construction that is integral with the main lift plinth.

The solution to position a new lift on the site of a demolished privy shaft and ground-floor extension was inspired. Historically, penetrations had been made through the side wall of the palace at all levels, so reusing them merely involved unpicking 1880s brick blocking. We insisted on having sight lines studies to ensure that a lift would not dominate key views within Kew Gardens. Our major concern was the detailing of a lead-covered 'throat' joining the shaft with the intricate brick elevation, and the unacceptable projection of the motor room above the second floor cornice. Due to the commitment of the project team, the 'throat' was refined, while the height was incrementally reduced until it was even lower than the agreed projection. The privy shaft had been timber clad, and EH sought a design which gave cognisance to that lost feature, while being expressed in a modern way. Consequently, we pressed for untreated oak cladding which reflected the general form of the lost shaft, but which would weather naturally and have an affinity with its garden setting.

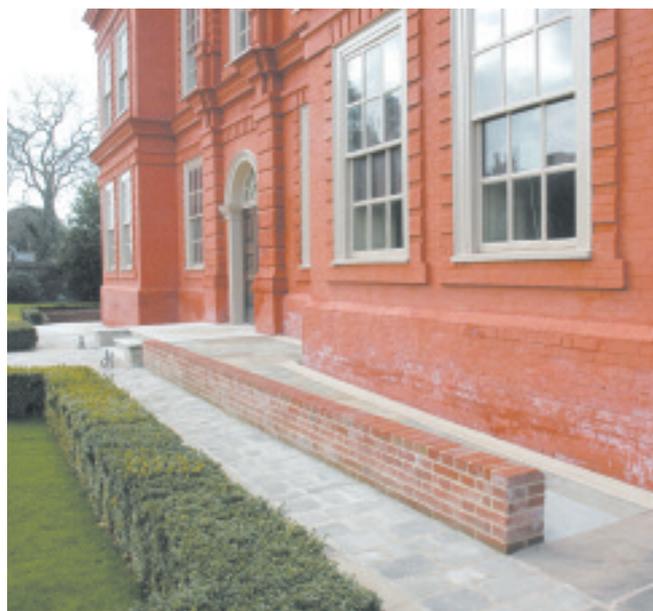
### ***Ramped access outside the front entrance to Kew Palace***

The problems of facilitating access for disabled people to the main entrance door are common to similar situations in which entrance steps and raised thresholds need to be overcome. At Kew, the threshold was 130mm above the original raised Portland stone landing which was three risers above ground level. Although visually sensitive, a new ramp to the landing would be relatively straightforward to install; however, the remaining threshold step would need to be resolved. Substantially altered, the existing stone steps held historical and archaeological significance which dictated options for any adjustment. Both HRP and EH contributed ideas toward the final solution by which the upper landing and steps were carefully dismantled and raised through the insertion of a new stone band set above base construction that remained undisturbed. The area of existing stone paving surrounding the steps was proportionately sloped up to new datums allowing the formation of a new ramp to a reduced gradient.

Although adjacent to the south wall, the ramp is physically and visually separated from the original plinth brickwork which preserves the latter's capacity for absorbing and shedding moisture.

The brick-vaulted basement could not be penetrated. The agreed solution of an external platform lift on the site of modern external steps provides basement access without impacting greatly on the exterior of the palace, while the low-profiled 1:21 slope to the ground-floor front entrance does not require a handrail.
